Liquitrend QMW43

Eliminate the need for manual inspection and transit to condition based cleaning

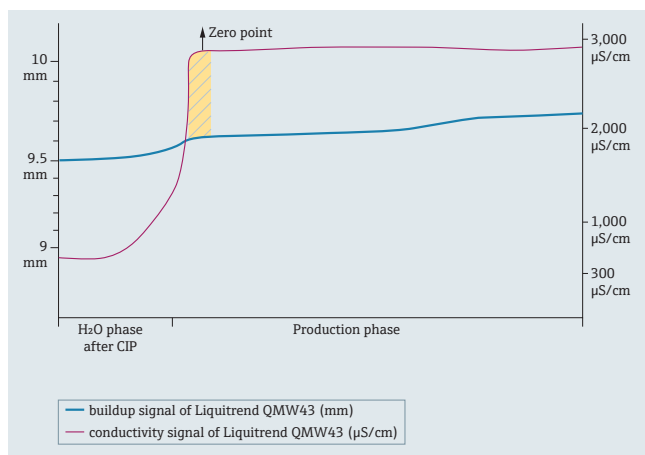
Zero point under product

After installing the Liquitrend QMW43 sensor, the entire installation was properly cleaned and filled up with water to determine the baseline = zero point in water in the clean installation. It was then filled with the production media for which the baseline was also determined. The buildup thickness/fouling rate was monitored throughout the production run to determine a trend. If the installation is emptied and clean, the sensor displays 0.0 mm.

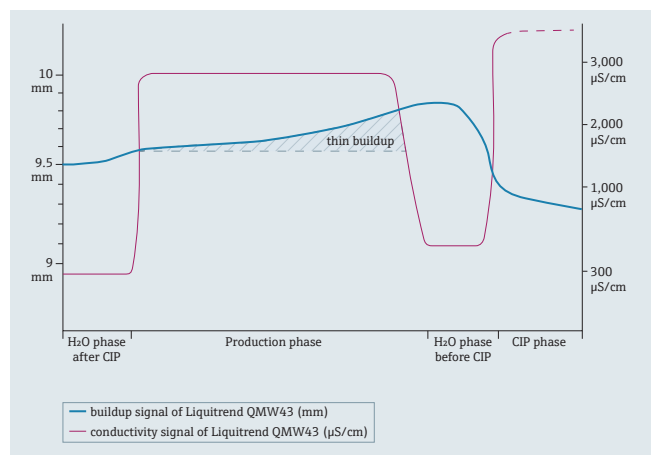
Buildup formation during production

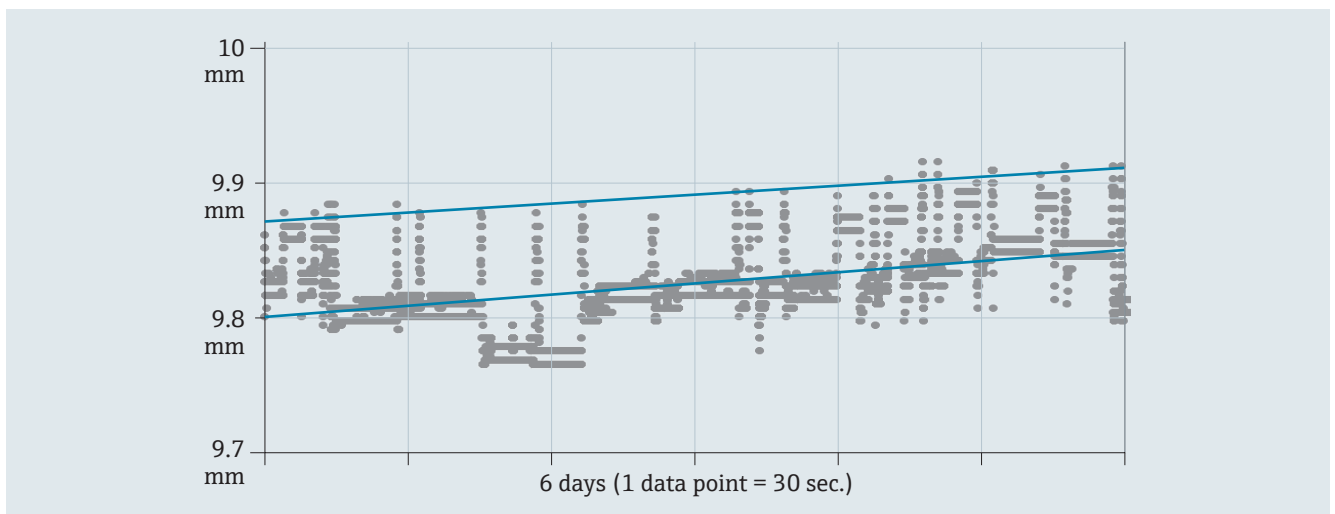
A long production run was initiated with product change overs in between using water as the push-out medium. Over time, a thin build up was observed to form on the piping surfaces which can be seen from the zoomed-out illustration of the buildup thickness (as seen at the picture above). The relative buildup thickness/fouling during the production run in the filled installation increased as indicated by the Liquitrend QMW43 buildup signal.

The Liquitrend QMW43 signals were used and evaluated for a duration of 3 months. Monitoring the buildup formation during production runs, the customer was able to determine that the rate of fouling increased with multiple product changeovers.

With these signals, the customer could determine a buildup thickness level when to initiate a CIP run and therefore evolve to status-based cleaning.

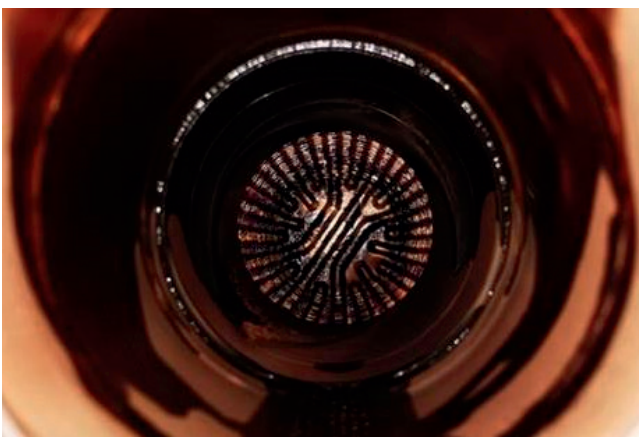
At the end of the production run, a standard CIP process was initiated as usual to remove the accumulated buildup in the installation. The installation was emptied after the CIP. However, with the signals from Liquitrend QMW43 the need for manual dismantling was eliminated because he saw that the installation was not properly cleaned. When this occurred the first time, a confirmation of the suspected buildup was needed. The buildup signal of the emptied installation was 0.1 mm instead of 0.0 mm expected for a clean empty installation! To confirm the suspected residual fouling, the installation was manually dismantled for visual inspection. This verified that everything was indeed coated with a thin film of residual buildup (as seen in the picture below).
